# **FTU Toolmark Worksheet**

Notes: Erich D. Smith	File Number: 415M-BS-2814367		
Specimens: Q608	Laboratory Number: 130420100 AAR NN

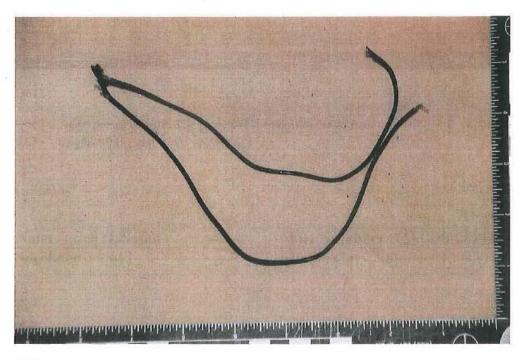
Q608 is a piece of wire. The Q608 wire has green/dark green insulation (sooting), diameter 0.09", length  $\sim 1.0$ ", inner wire appears to be missing, ends of insulation appear to have been torn -NMOV.

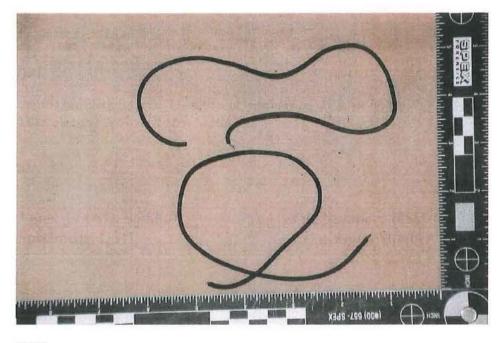
Q612 is a two pieces of wire. The pieces of wire have a gray/green insulation with copper inner wires, diameters 0.085", lengths 10.0", and 9  $\frac{1}{4}$ " – NMOV.
